***Technical Memorandum 33-573***

***The Mariner Mars 1971 Radio  
Frequency Subsystem***

*R. S. Hughes*

JET PROPULSION LABORATORY  
CALIFORNIA INSTITUTE OF TECHNOLOGY  
PASADENA, CALIFORNIA

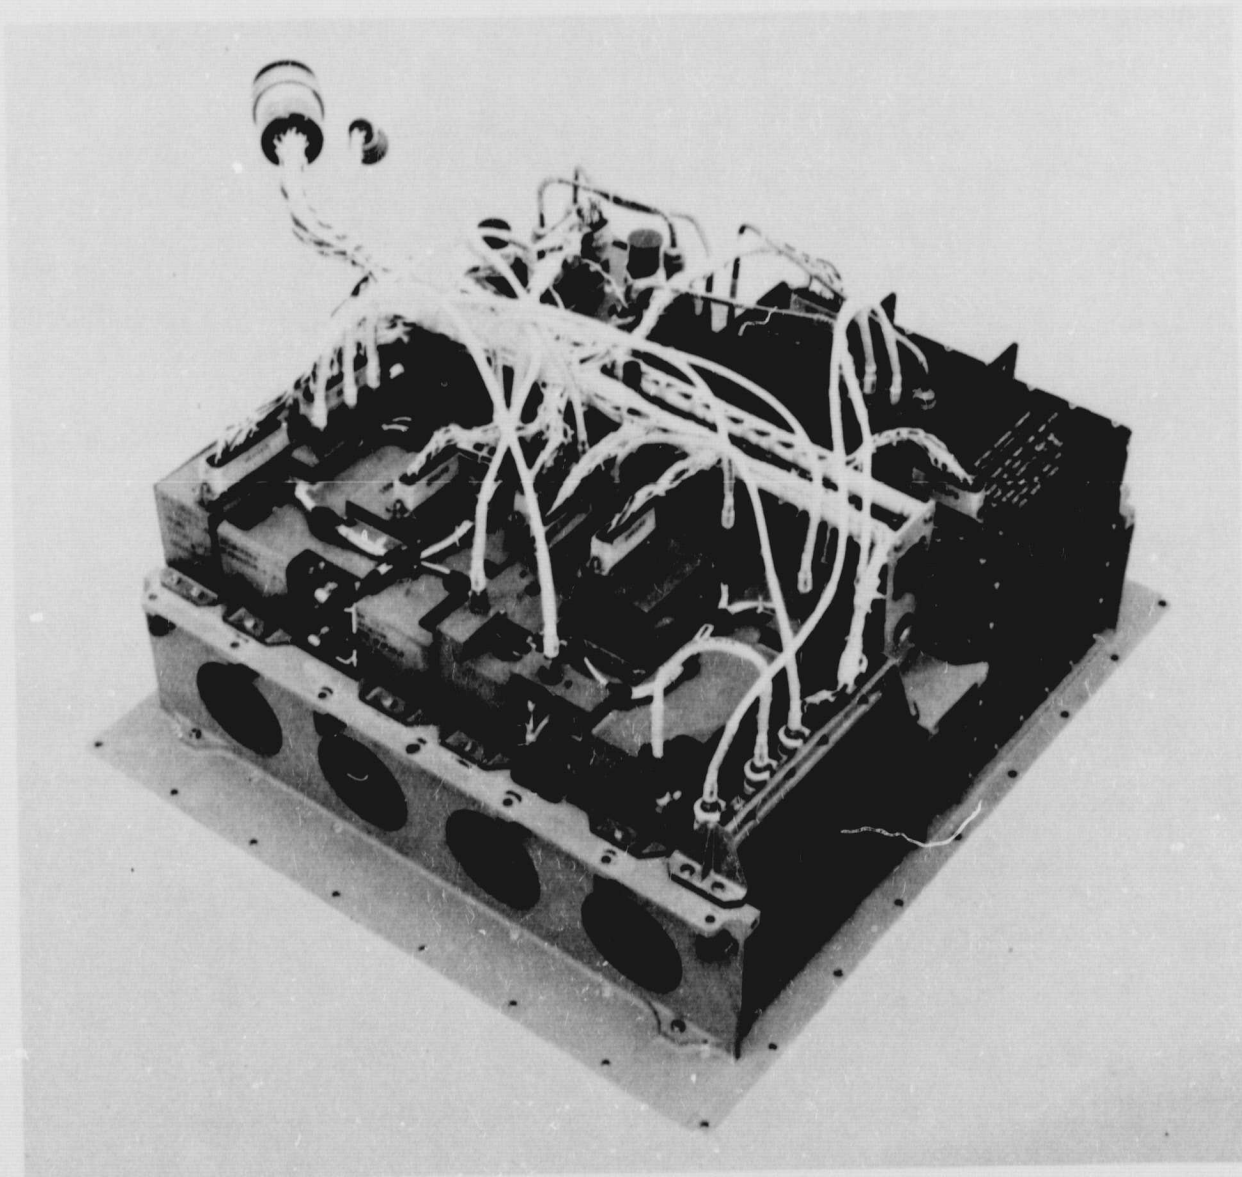
Fig. 1. MM'71 RFS

The Mariner Mars 1971 (MM'71) radio frequency subsystem (RFS) provides the communication link between the spacecraft and the ground-based Deep Space Instrumentation Facility (DSIF). The functions of the RFS, shown in Fig. 1, are to

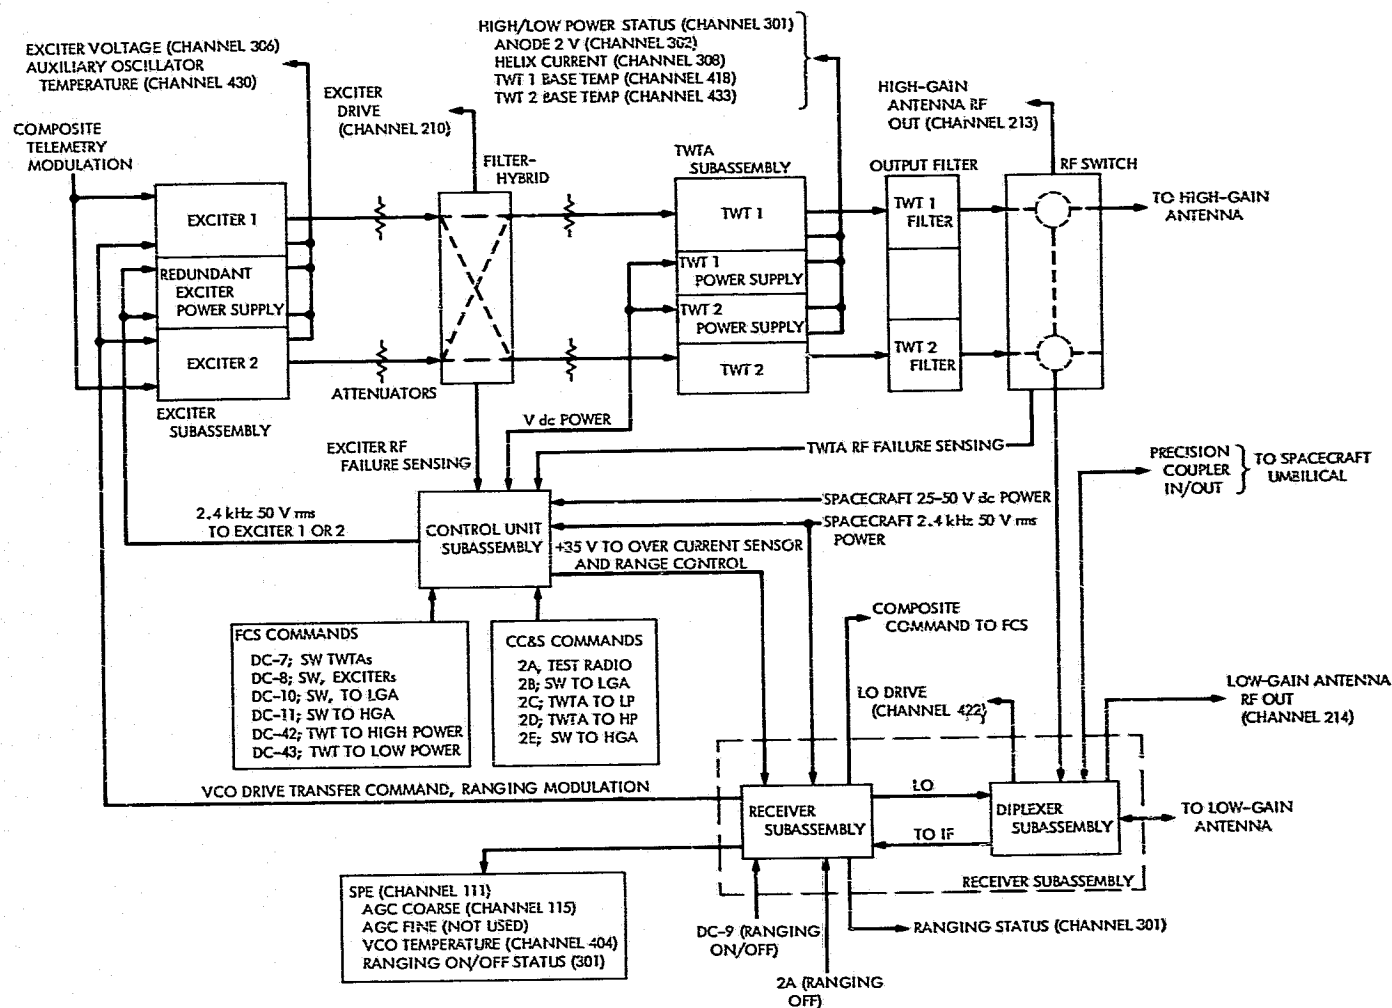
Fig. 2. Radio frequency subsystem block diagram

The RFS consists of the four subassemblies and the microwave components shown in Fig. 2. The major subassemblies are the receiver, the exciter, the traveling wave tube amplifier (TWTA), and the control unit subassemblies. The microwave components consist of the dual RF switch, the filter hybrid, the output filter, and the diplexer.

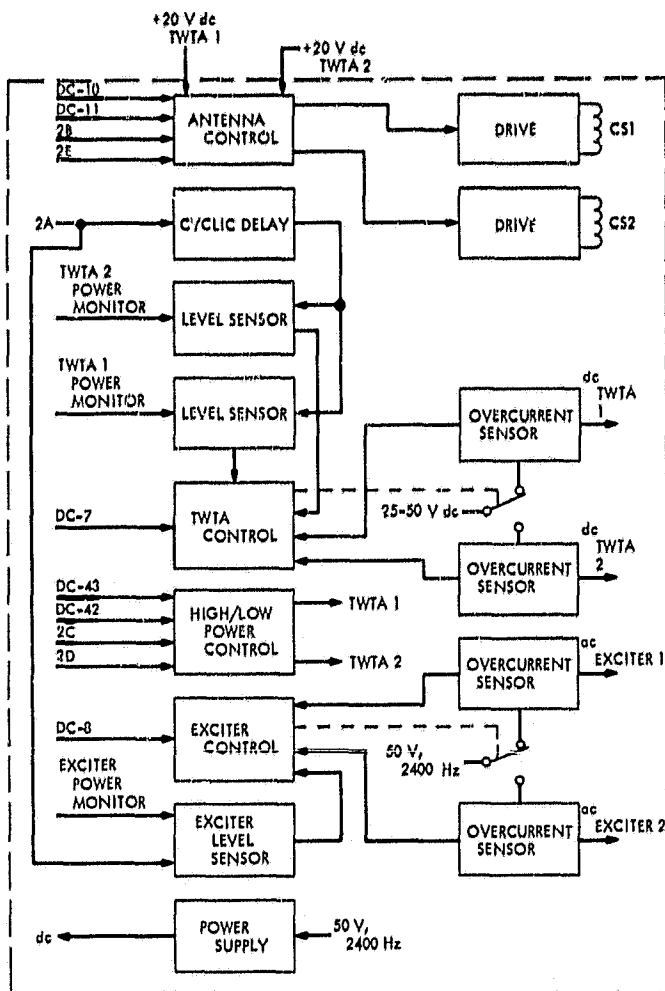
Fig. 6. Control unit block diagram

The control unit accepts direct commands from the FCS, the CC&S, and the failure-sensing circuits in the RFS. It selects the appropriate RFS operating mode. The functions of the control unit are to

- (1) Control the circulator switches to direct the output from either TWTA to the high-gain or low-gain antenna upon receipt of a suitable command from the FCS or CC&S.
- (2) Sense the TWTA and exciter power level and, if it is low, switch to the redundant unit upon receipt of the CC&S 2A cyclic command.
- (3) Sense overcurrent conditions in the TWTA and exciter power supplies and switch immediately to the redundant unit; switch to either redundant element upon receipt of a direct command from the FCS.
- (4) Select high or low power output from the TWTA upon receipt of a command from the FCS or the CC&S.
- (5) Sense overcurrent in the receiver power supply and remove its prime power if such a condition exists. The prime power is reapplied to the receiver upon receipt of each subsequent CC&S 2A cyclic command.
